CASE STUDY: Southampton Waters/Eling Marsh Revetment Works

Environmental Sensitive SSSI Area. Pylon Foundation Revetment Works

PROJECT DETAILS

CLIENT: SSEN

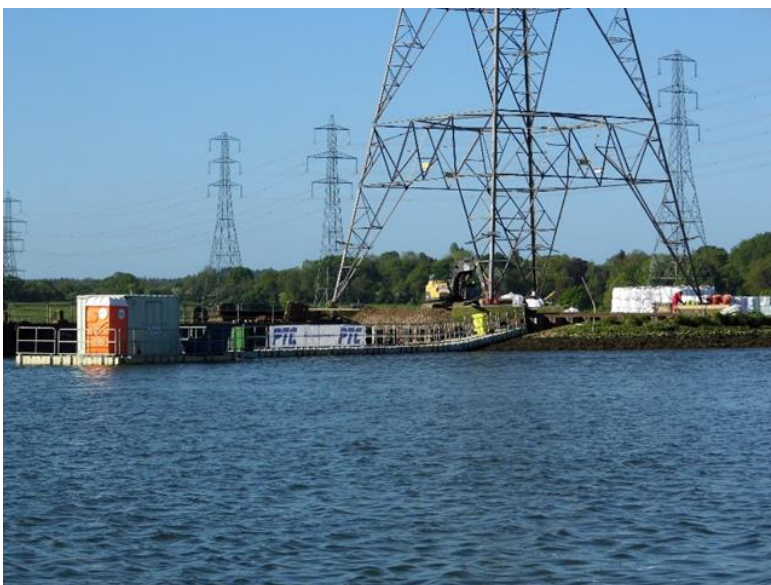
Environmental Sensitive SSSI Area. Pylon Foundation Revetment Works

Sheet piling was installed around each pylon base to protect from further erosion. Gabion stone was placed to the front/water's edge to protect from further erosion, above that and over the flat base was capped off with multi graded sized shingle as recommended suitable by local Wildlife Trust, creating additional habitat as a High-Water Roost area, or possible Nest Site for Turns and Plovers.

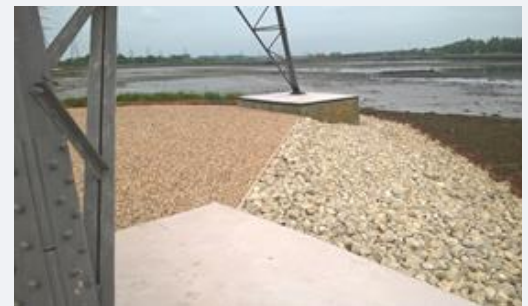
Completed Piling & Revetment Works

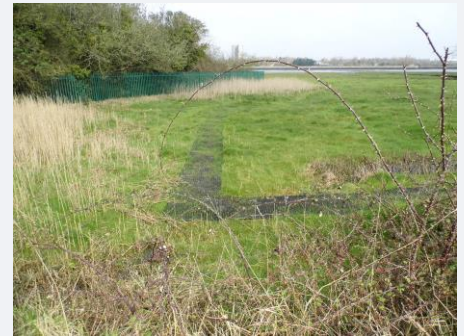
Protection matting for pedestrian access across marsh

Protecting marsh ecology with special matting for pedestrian access. Resulting in no long term impacts.

Objective for Zero long-term damage to marsh achieved through change of main access to seaward, foot traffic only on designated protection path over marsh.

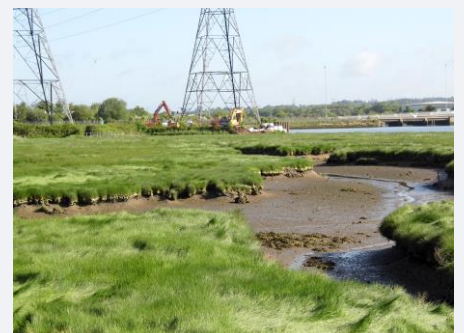
Bridging creeks safely

Site access restrictions: Foot traffic only via Marchwood industrial estate (ABP kindly granted access) Restrictions on sticking to the installed protection mat pathway and scaffold bridges (North Pylon) or via the causeway (South Pylon) any plant/materials had to come via a barge including fortnightly consumables like fuel, water and waste and no night time working.

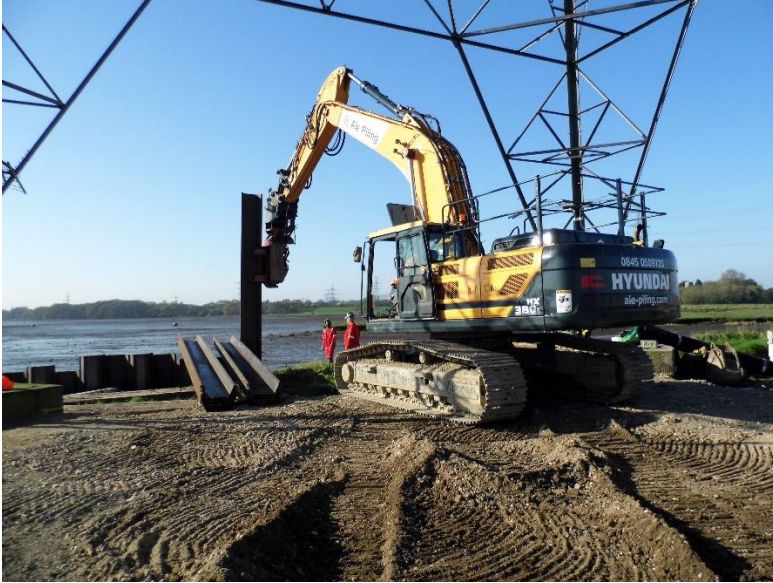
Double Banksman in use due to tight space constraints

Space was very constrained, it took considerable skill and experience from the plant operators and banksmen whilst operating. Housekeeping had to be "best in class" due to the nature of environment and very limited space for storage. One of the many additional control measures put in place was the use of double banksmen per machine to ensure we had no unplanned events like striking the pylon legs. The whole project was conducted a live environment beneath the live 132k network. Another key measure taken was the installation of a floating 45m jetty/dock/welfare unit. Rescue and workboats were in use throughout the contract. The jetty was a twofold aspect, providing both space saving welfare/storage and providing a safe access/egress point to the site 24/7 in case of emergencies.

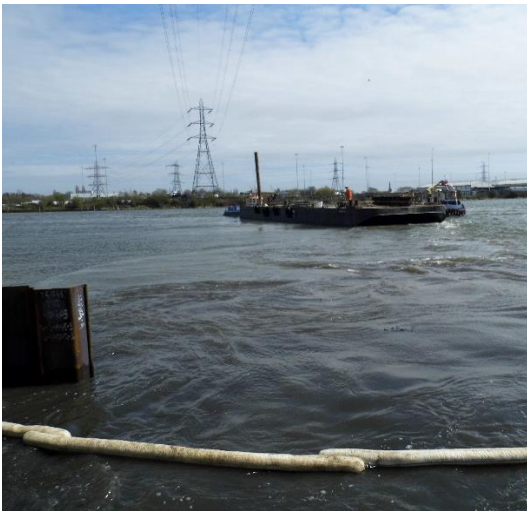
Multiple barge movements planned and coordinated around the spring tides, delivering all plant, equipment and materials.

Multiple barge movements were planned over a 10-week period to provide all plant/equipment and materials to both pylon sites at Eling Marsh close to Marchwood and Totton.

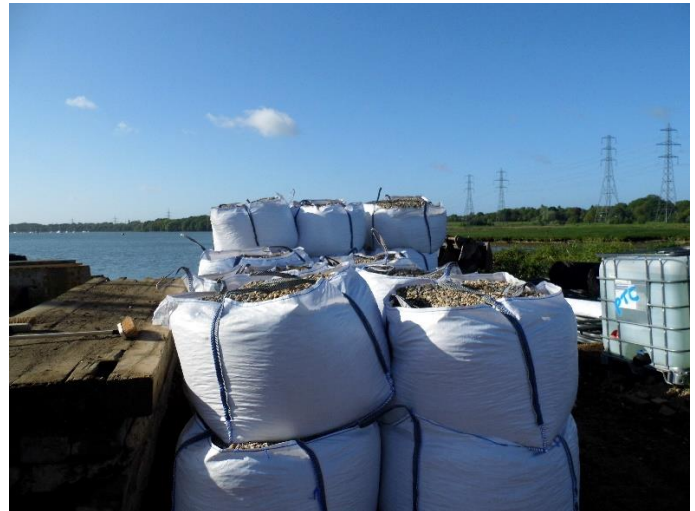
All materials had to be handled multiple times, delivered in dumpy sacks and stored like a military operation.
